PeakVue Analysis for Antifriction Bearing Fault Detection

Peak values (PeakVue) are observed over sequential discrete time intervals, captured, and analyzed. The analyses are the (a) peak values (measured in g's), (b) spectra computed from the peak value time waveform, and (c) the autocorrelation coefficient computed from the peak value time waveform.

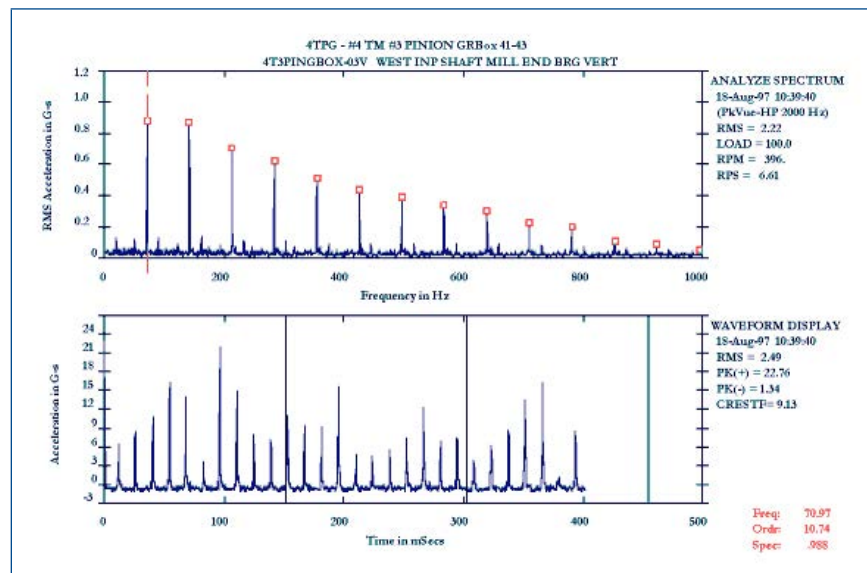
The PeakVue spectra and time waveform data are presented in Fig. 1. A high pass filter of 1000 Hz was used. Significant activity at the outer race defect frequency with many harmonics is present. The impact levels are as high as 37 g's.

Figure 1: PeakVue Spectra and time waveform from input shaft of pinion stand gearbox

Although many harmonics are present in the spectral data, it is obvious from the PeakVue time waveform that the time between impacts corresponds to the outer race fault frequency (the harmonics are of no physical significance). This is also demonstrated in the autocorrelation coefficient function presented in Fig. 2.

The impacting levels trended from 18 g's in July to a high of 37 g's in September. The levels had decreased to 14 g's in October prior to a bearing replacement.

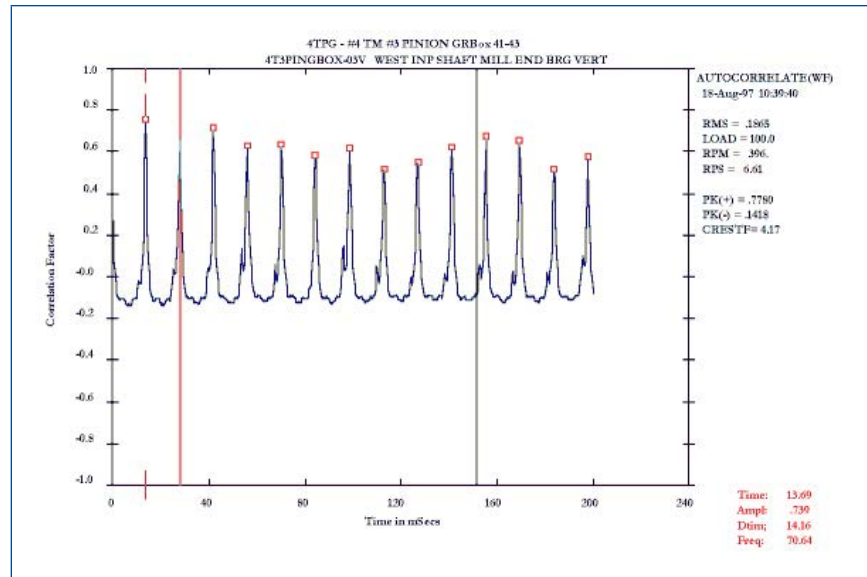
Figure 2: Autocorrelation coefficient from PeakVue time waveform in Fig 1

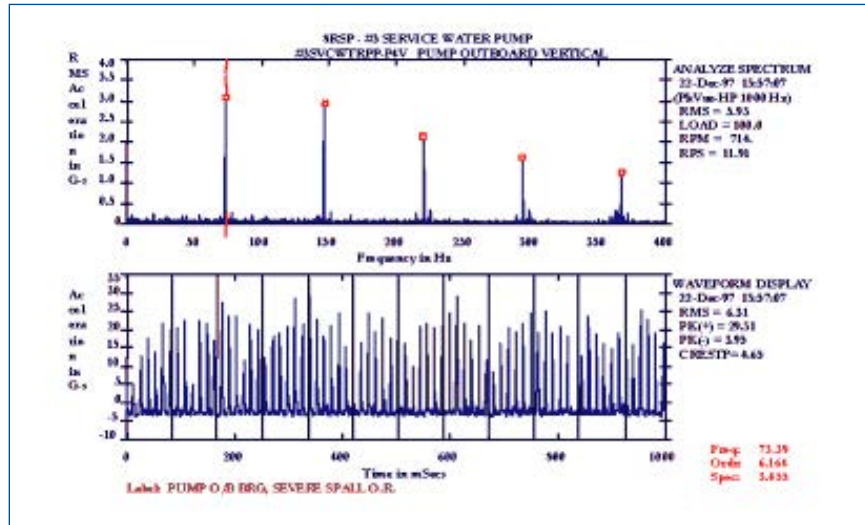
The second case study is from a centrifugal service water pump rated at 12000 gpm driven by an 8 pole 700 hp motor. Normal route-based vibration monitoring identified an outer race defect of reasonably low level (the peak-to-peak g level was 1.5 g's). The fault was identified as "alert" and hence was to be trended. On December 8, 1997, PeakVue was employed and showed both outer and inner race defects with a signal level of 10 g's. A second PeakVue reading was taken on December 22, 1997 and is presented in Fig. 4. The impacting levels had increased to 33 g's. The pump was then placed on the "fault" level and the bearing was replaced. The autocorrelation coefficient computed from the PeakVue time waveform is presented in Fig 5. The autocorrelation coefficient data shows the only activity of significance is the impacting from the outer race defect.

Figure 4: PeakVue spectra and time waveform from outboard on service water pump

In this case, normal vibration data did identify the fault; however, the low levels observed did not place the fault at a level of significant concern. The impacting levels identified in PeakVue, excess of 30 g's, raised the concern level and initiated planning for replacement.

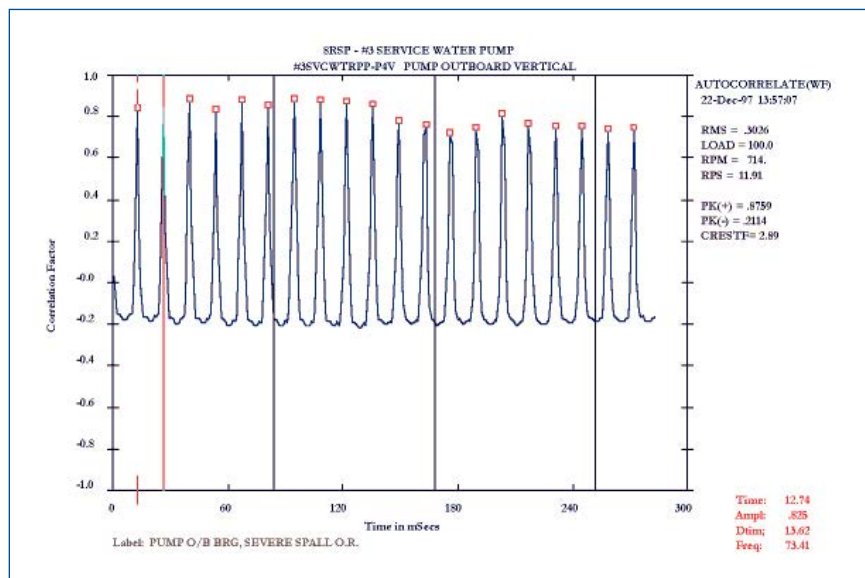
Figure 5: Autocorrelation coefficient from PeakVue waveform in Figure 4.

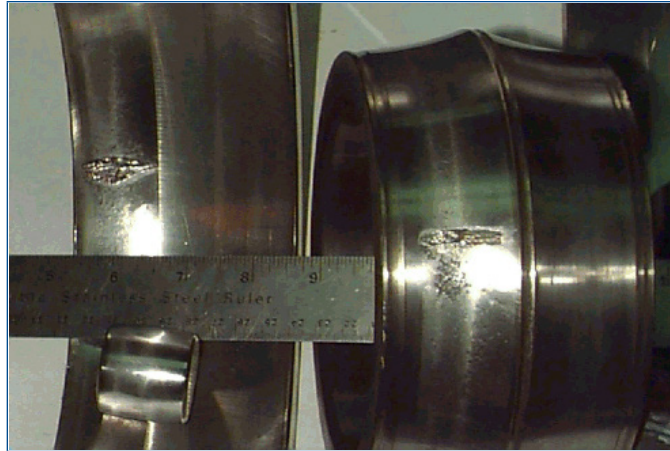
Figure 6: Photograph of defective service water pump bearing, showing inner and outer race spalling.

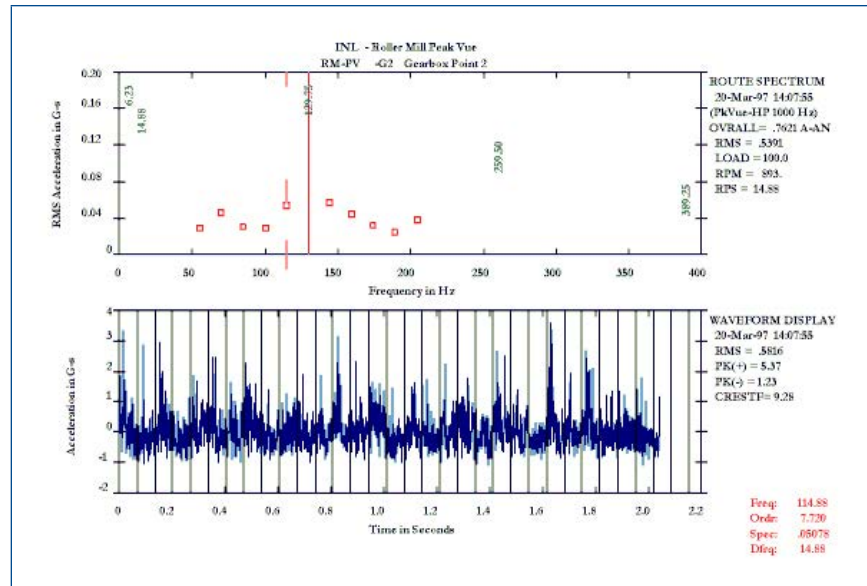
The PeakVue data acquired March 20, 1997 are presented in Fig. 7. The cage activity at 6.23 Hz (0.42 orders) is identified. The inner race defect (129.75 Hz) at 8.72 orders is being sidebanded by running speed. The inner race defect was not detected in the normal spectral analysis.

Figure 7. PeakVue spectra and time waveform from inlet of crusher gear box.

The bearing was replaced in June, 1997. The inner race had deep spalling over an approximate 1.5 area.

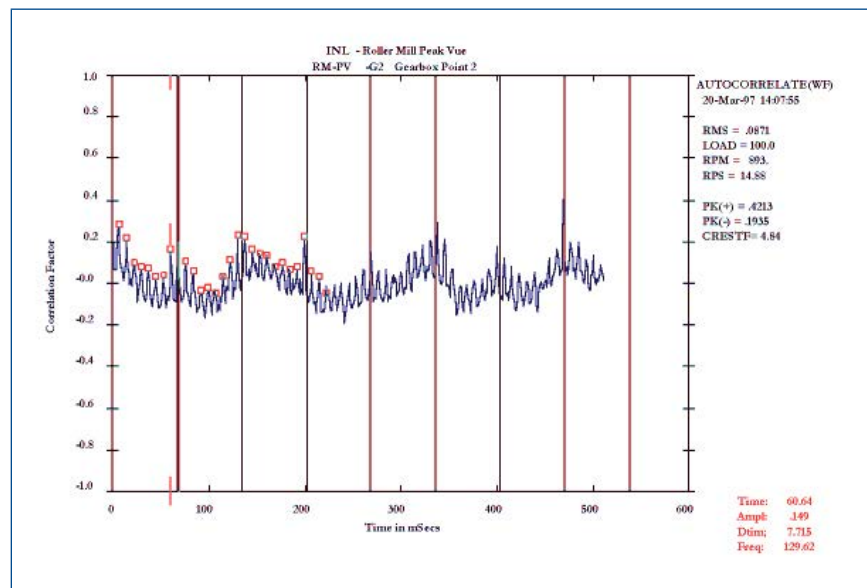
Figure 8. Autocorrelation coefficient from PeakVue time waveform of Figure 7.

The autocorrelation coefficient function computed from the PeakVue time waveform in Fig. 7 is presented in Fig. 8. The inner race defect is clearly evident with amplitude modulation at running speed. The peak g levels for an inner race are generally not as large as for those accompanying an outer race defect. This is expected since the stress waves accompanying an inner race defect will experience attenuation in reaching the outer peripherals (where the sensor is attached) of the machine.

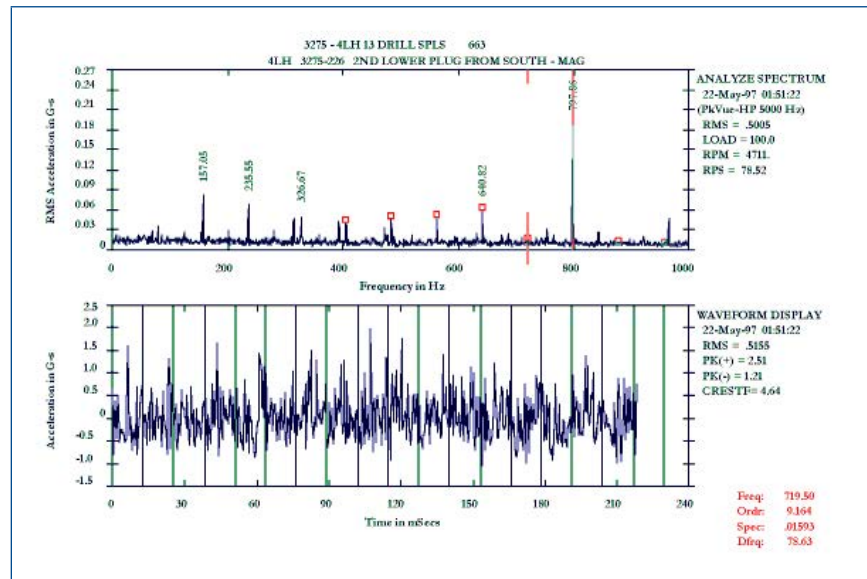
Figure 9. PeakVue spectra and time waveform from a spindle on a 13 multi-drill head spindle.

The PeakVue spectra and time waveform for a spindle with a confirmed inner race defect are presented in Fig. 9. The inner race defect at 797.86 (10.2 orders) Hz is identified with side banding (twice running speed is dominant). The autocorrelation coefficient function computed from the PeakVue time waveform is presented in Fig. 10. The dominant activity here is at the inner race defect frequency. The bearing was replaced. The bearing had deep spalling on the inner race.

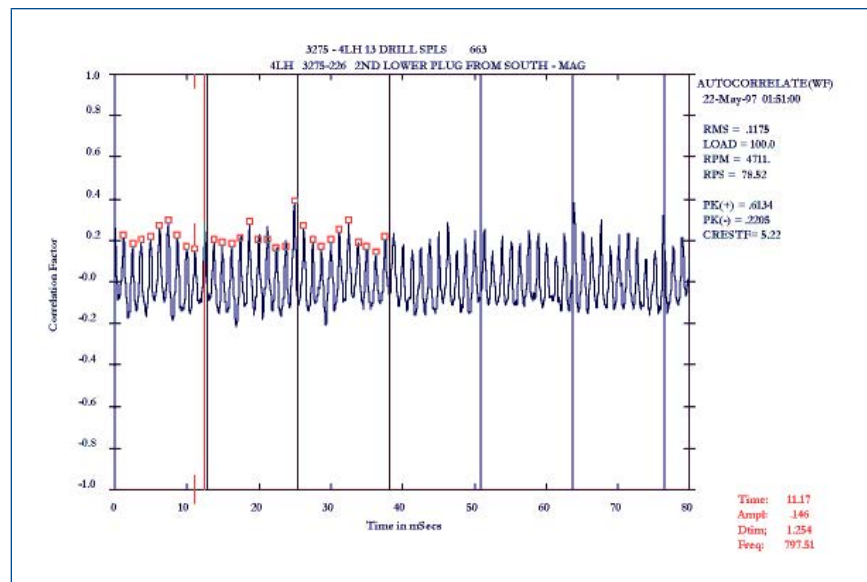
Figure 10. Autocorrelation coefficient from PeakVue time waveform acquired on the spindle of Figure 9.

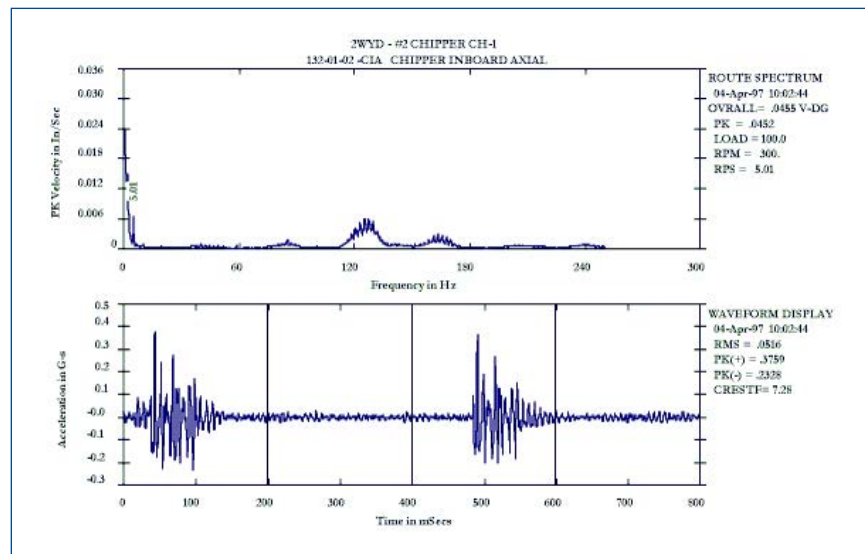
Following a shutdown where work was done on this chipper machine, the acceleration time waveform for a 500 Hz bandwidth spectra indicated some impacting may be occurring, see Fig. 11. The p-p g levels were less than 1 g which are not judged to be significant. The velocity spectra had a low 1x component but there were no obvious bearing faults.

Figure 11. Velocity spectra and acceleration time wave form from inboard axial on a chipper.

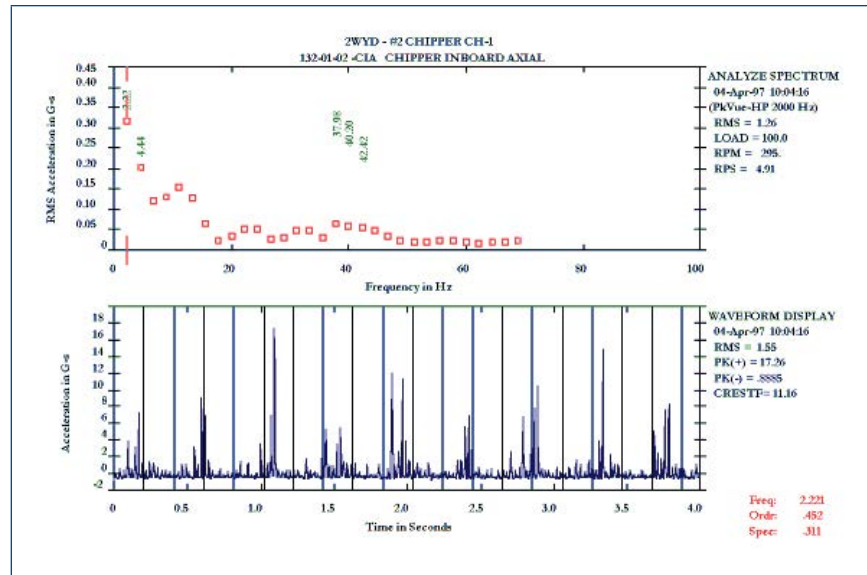
Figure 12. PeakVue Spectra and time waveform from inboard axial on chipper.

A PeakVue data set was acquired at about the same time using a high pass filter of 2000 Hz. The resulting PeakVue spectra and time waveform are presented in Fig 12. The impacting level is near 20 g's and the cage and twice ball spin frequencies are dominant. This pattern is indicative of two impacts per revolution of the ball that is passing through the load zone at the cage repetition rate. From the PeakVue spectral data, it is not obvious whether the 38, 40.2, or 42.4 Hz peaks are representative of twice ball spin. The autocorrelation coefficient function data, presented in Fig. 13 clearly identifies the dominant activity is at 40.2 Hz which is twice the ball spin frequency. The autocorrelation coefficient data also clearly shows the defective ball going in and out of the load zone at the cage turning speed.

The root cause of this problem was found to be improper grounding of an electrical welder used during the recent outage.

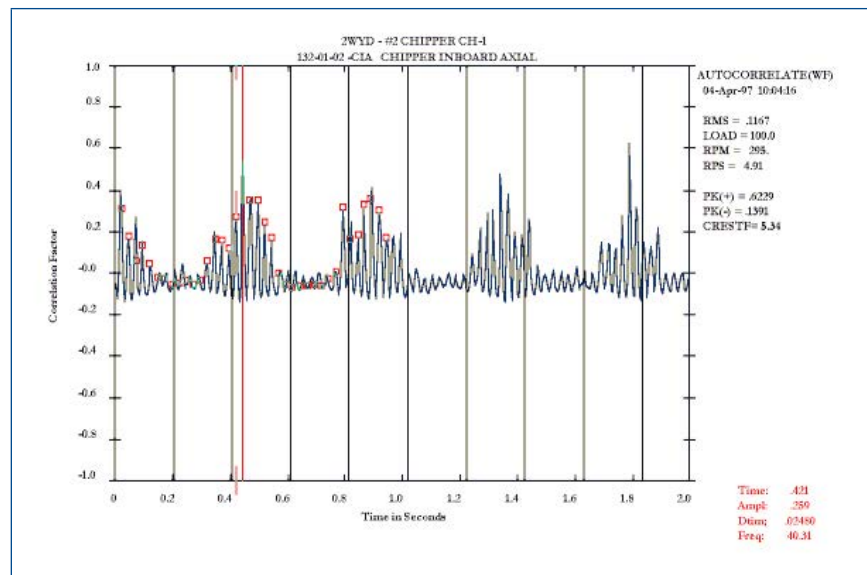
Figure 13. Autocorrelation coefficient from PeakVue time waveform of Figure 12.

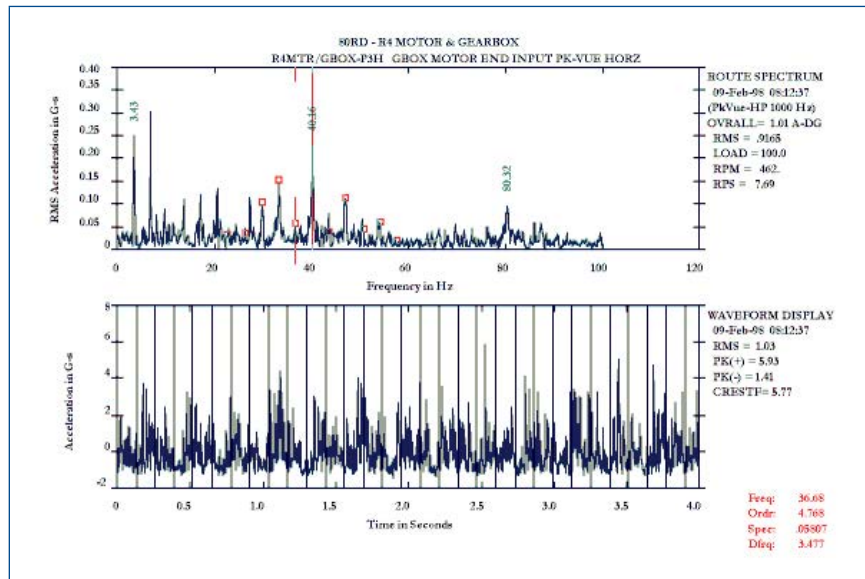
When data was acquired on the inlet pinion shaft bearing on January 2, 1997, impacts in the 6 g range were detected with the PeakVue spectra showing ball spin fault modulated by cage. On February 9, 1997, the impacting level had increased to 9 g's. The PeakVue data are presented in Fig 14. The ball spin fault frequency is at 40.4 Hz and cage at 3.43 Hz. The autocorrelation coefficient is presented in Fig. 15 which emphasizes the cage and ball activity. A photo of the defective bearing is presented in Fig. 16.

Figure 14. PeakVue Spectra and time waveform from inboard pinion rougher gear box.

The bearing was replaced and PeakVue data acquired on February 12, 1997. The impacting level had decreased to less than 1 g. The normal vibration never showed any indication of a bearing problem.

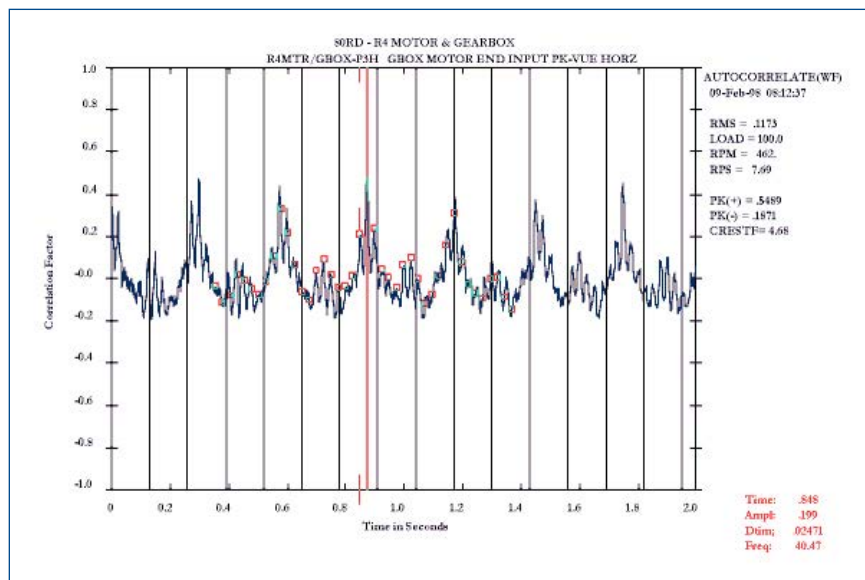
Figure 15. Autocorrelation coefficient from PeakVue time waveform of Figure 14.

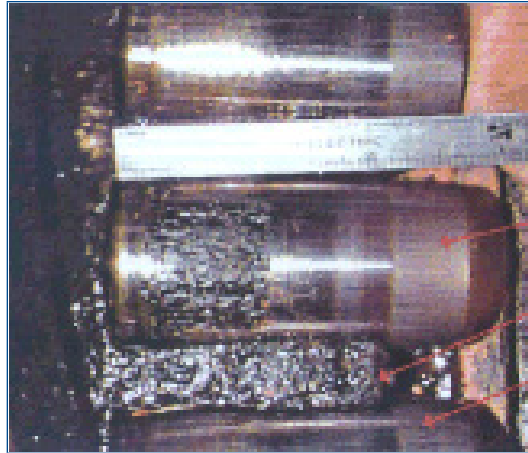
Figure 16. Photograph of defective bearing highlighting the rollers.

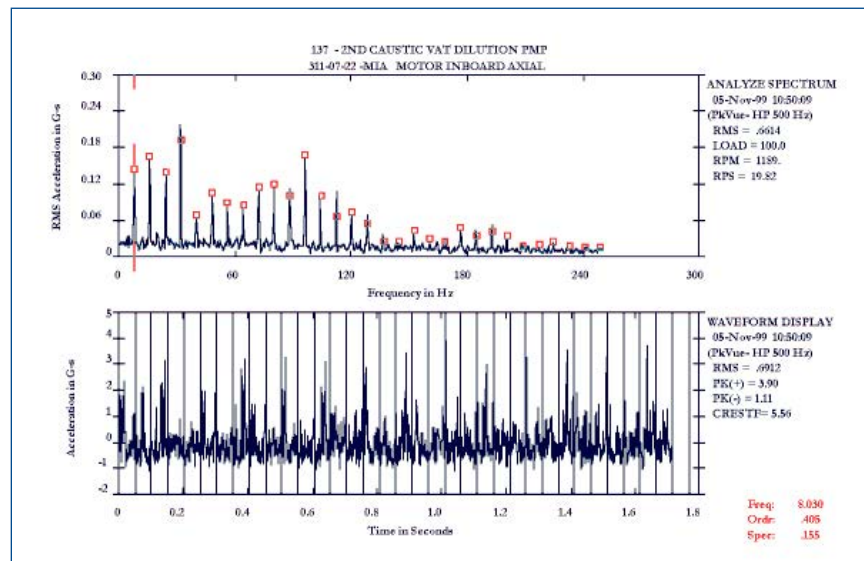
The PeakVue data from the inboard bearing on a motor (150 hp) directly driving a centrifugal pump are presented in Fig. 17.

Figure 17. PeakVue spectra and time waveform from Motor (Inboard Axial) driving direct coupled centrifugal pump.

The impacting levels are 5 g's which are not excessive for this speed machine but definitely indicative of a problem. The spectral data is dominated with cage and many harmonics. This is a NSK NU 318 bearing which has 13 rolling elements.

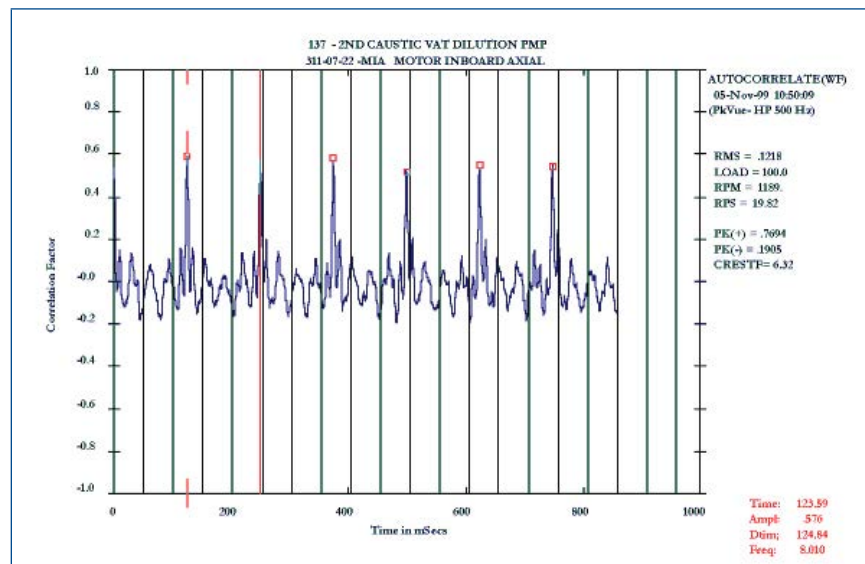
The autocorrelation coefficient data computed from the PeakVue time waveform are presented in Fig. 18. The only significant activity is the cage activity.

Figure 18. Autocorrelation coefficient from PeakVue time waveform of Figure 17.

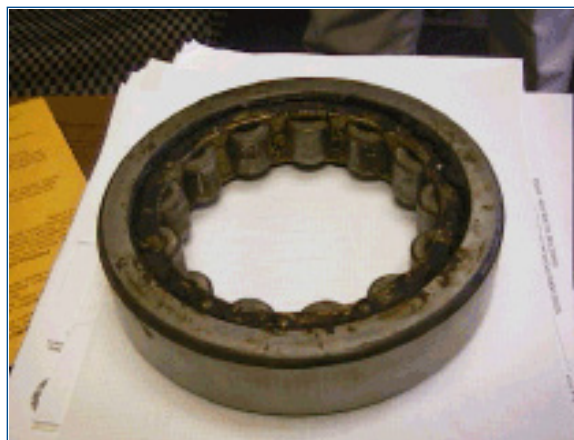
A photo of the defective bearing is presented in Fig. 19. The rolling elements show indication of "skidding," but the dominant problem is the "caked" residue of lubricant (grease).

Figure 19. Photography of the defective bearing highlighting the "caked" residue of lubricant and skid of roller 5.

This bearing is being replaced with a rolling ball element bearing. The problem of grease being "pushed out" is not uncommon with cylindrical rollers in low radial load applications.

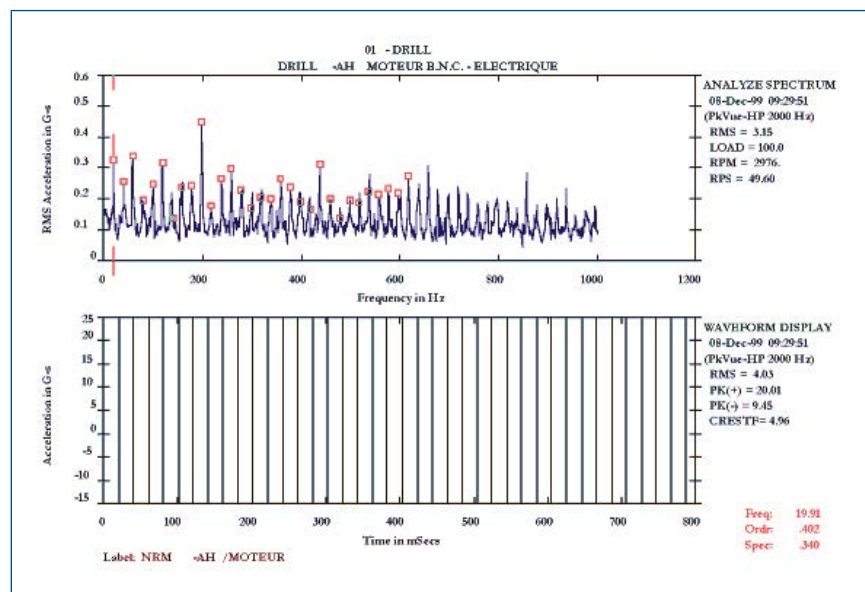
The PeakVue data taken with the sensor mounted vertically over the outbound bearing on the male 4 vane rotary screw are presented in Fig. 20. Given how the sensor was mounted, the 30 g peak impacts seen in the PeakVue time waveform are considered significant. The activity are primarily many harmonics of cage frequency. The autocorrelation coefficient data presented in Fig. 21 also identifies cage as the dominant source of the activity.

Figure 20. PeakVue Spectra and Time Waveform on the outboard bearing of the male rotor and simple stage compressor.

This type activity has been observed before in cases where a) lubrication problems are present, b) where heavy preloads are present, c) where out-of-round race ways are present, and d) where heavy thrust loads are present.

Given the “newness” of this compressor and lack of similar activity on the female rotary screw, the lubrication problem is placed low on the suspected source. This leads to the conclusion that there could be excessive thrust for the bearing or out-of-round race way. In any event, cage activity generally is an indicator of a developing problem and should be trended closely.
